Engineering Geological Assessment of Selected Landslide Dams Formed from the 1929 Murchison and 1968 Inangahua Earthquakes

A thesis
submitted in partial fulfilment
of the requirements for the degree
of
Master of Science in Engineering Geology
at the
University of Canterbury
by
Timothy Richard Nash

UNIVERSITY OF CANTERBURY

2003

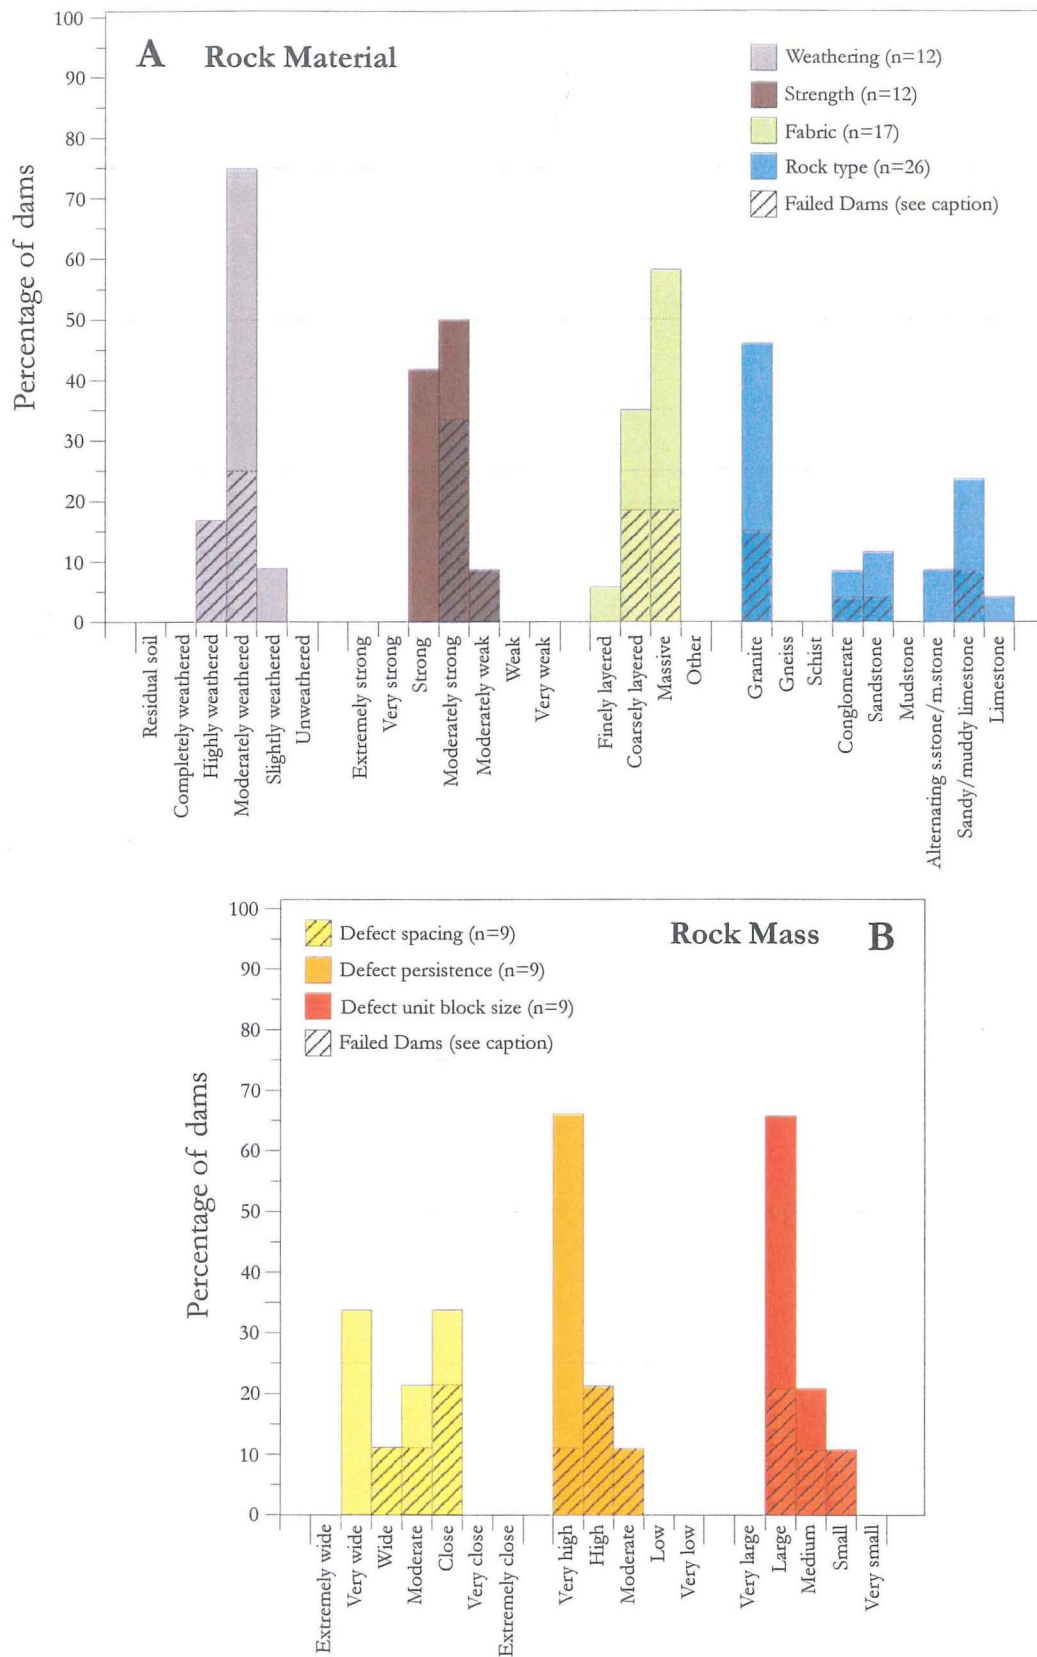
Of the 17% of landslides that are highly weathered, 100% failed. Of the 75% of landslides that are moderately weathered, 33% failed. The remaining 8% of slides that are slightly weathered none failed.

Of the 17% of landslides that are moderately weak, 100% failed. Of the 50% of landslides that were moderately strong, 67% failed. The remaining 33% of slides material that was strong none failed (Fig 3.3a). This is attributed to the material being strong enough (assuming this material comprised the bulk of the dam material) to resist erosion from overtopping and internal piping.

Of the 59% of landslides that are massive, 30% of the associated dams failed and of the 35% of landslides that are coarsely layered, 50% failed. No dams failed that are associated with the remaining 6% of slides material classified as finely layered (Fig 3.3a).

Fig 3.3. Rock material characteristics of initial dam-forming landslide source area from various dams this thesis. Key in top right corner of histogram also indicates the number of dams used in the analysis of the associated parameter. Terminology based on Bell and Pettinga (1983) (see text for discussions relating relevance of these landslide parameters to damming).

Failed dams are represented in four of the six lithologies that comprise all 26 landslide dams in the dataset, with no failure in dams comprising alternating sandstone/mudstone or limestone (Fig 3.3a). The lithology of the source rock material does not significantly influence the stability of dams in this dataset.

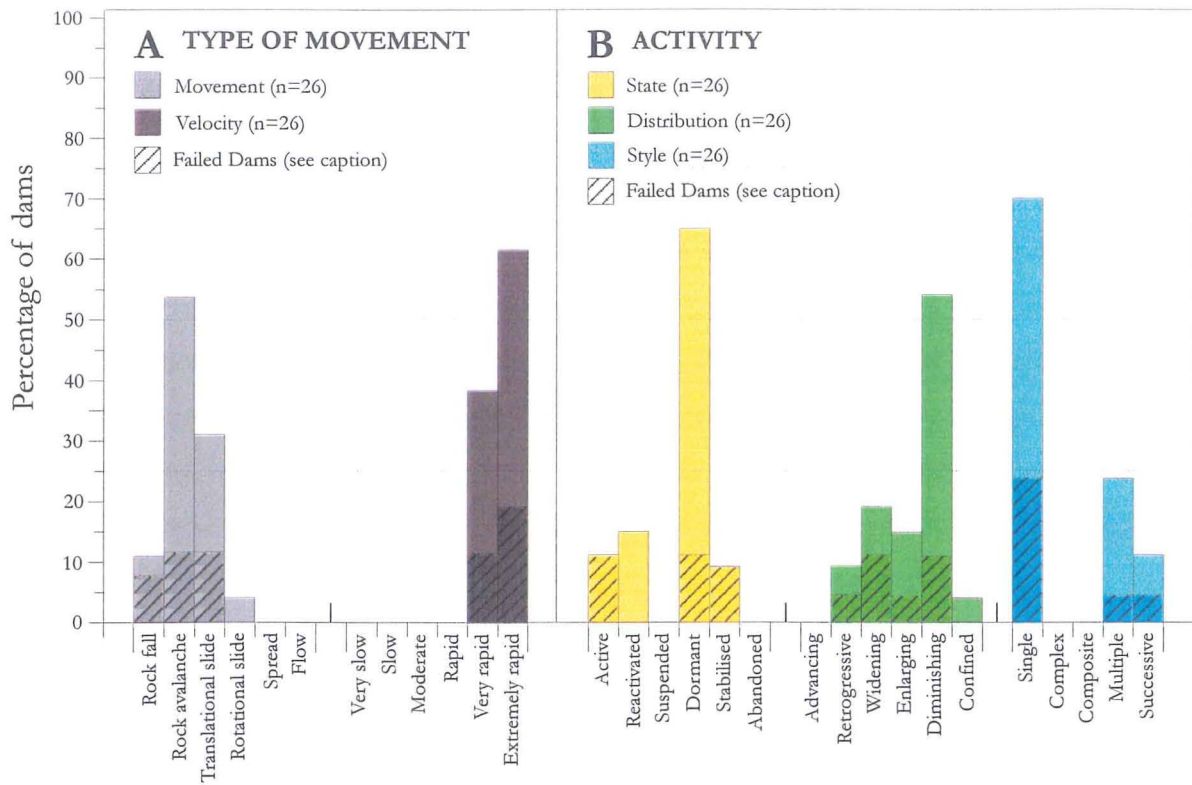
(Fig 3.4). Therefore, there seems to be no strong correlation between landslide type and stability of a dam from this dataset.

Of the landslides described as active or stabilised, all of the associated dams failed, 12% of the dams associated with dormant landslides failed, and no dams associated with a reactivated landslide failed (Fig 3.4).

Fig 3.4. Distribution of the classification of the initial dam-forming landslides associated with dams from this dataset. Failed dams refer to a dam status of MF, LF or CF (shaded areas). Non-failed dams represent a dam status of HS and S.

The association of the style of landsliding with dam failure is dominated by slides defined as single (33%) with 22% of multiple and successive dams failing. This shows a relatively poor correlation between landslide style and dam failure (Fig 3.4).

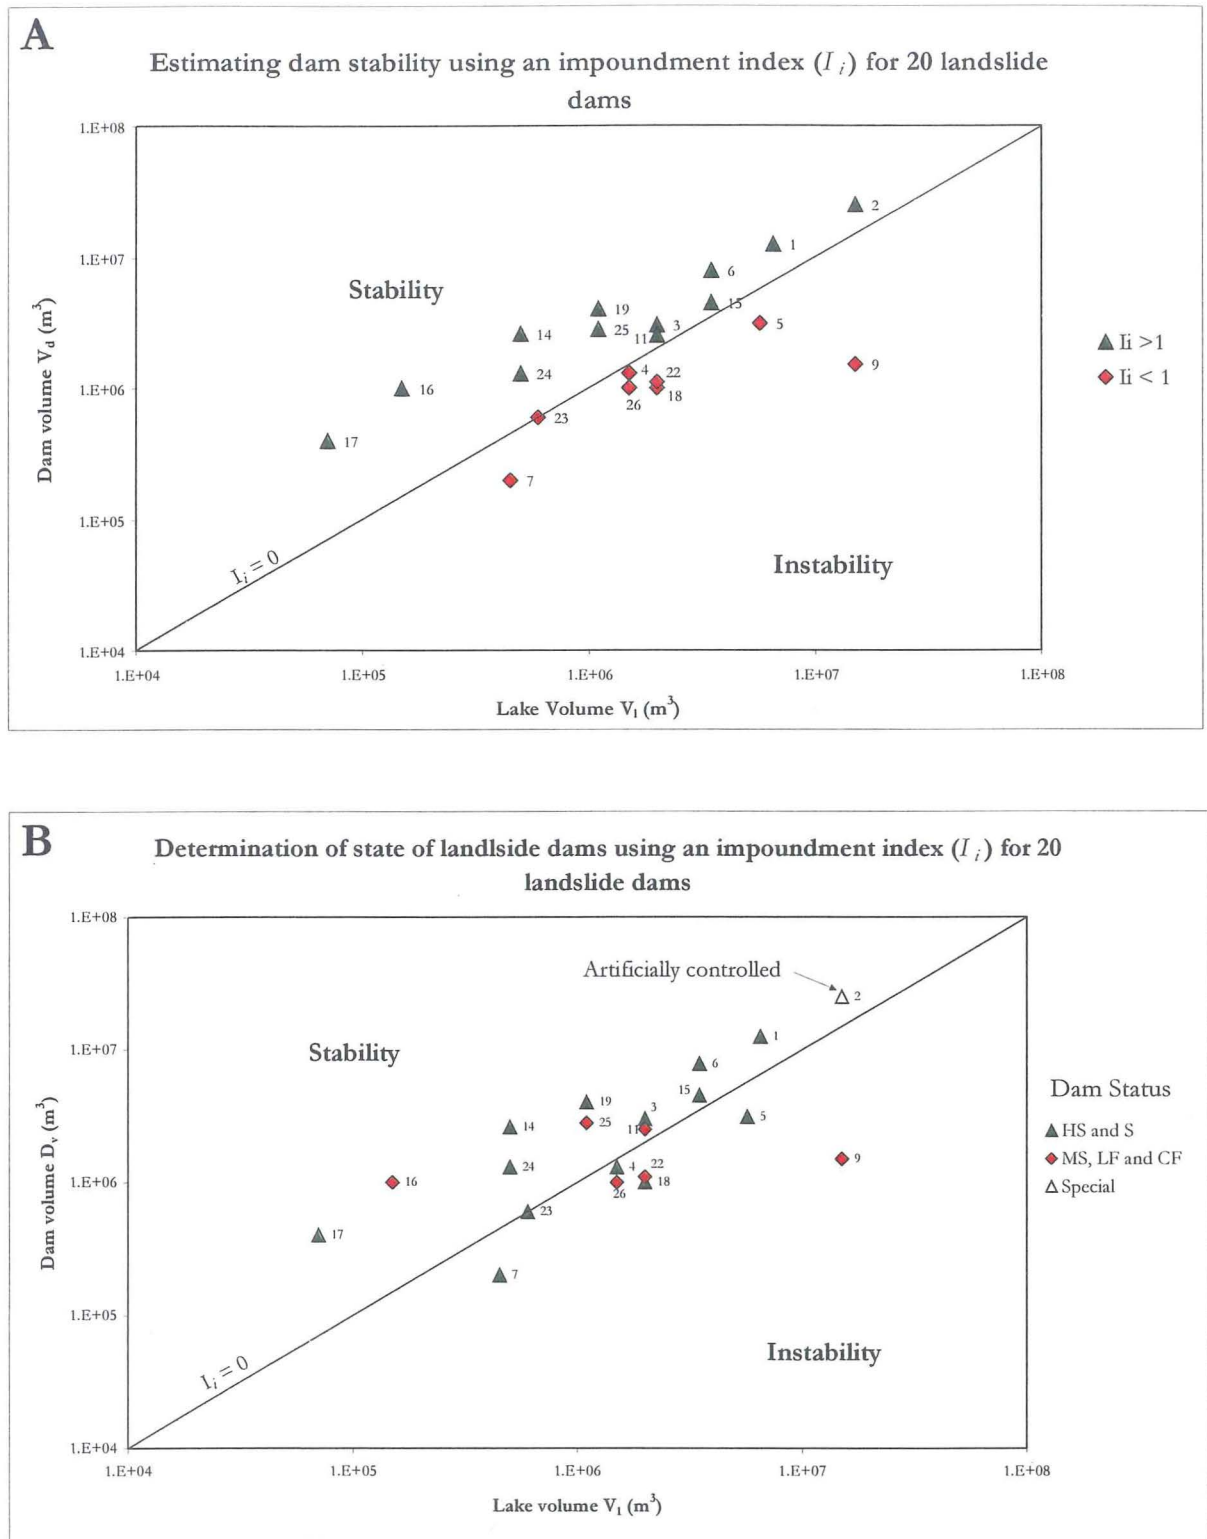
Fig. 3.6. A. Landslide dam volume versus lake volume defining stable and unstable domains for 19 landslide dams formed in northwest Nelson. Numbers adjacent to points refer to database reference number. **B.** Dam volume versus lake volume showing actual state of landslide dams from Fig. 24. Terminology is based on Casagli and Ermini (1999) in their description of stability and instability related to the state of a landslide dam (see text for terminology definition). Annotations relate to the dams labeled special.

12 of the 20 dams plot in the stability domain ($I_i > 0$), while the remaining eight plot in the instability domain ($I_i < 0$) (Fig 3.6 a). This is the predicted post-formation development of the 20 dams based on their dam and lake volumes following their formation.

- Eight of 13 dams characterised as HS or S (excluding Matakkitaki No. 2) plot correctly in the stability domain on the log-log graph ($I_i > 0$), the remaining five plot incorrectly in the instability domain ($I_i < 0$) (Fig 3.6 b)
- Three of six dams characterised as MS, LF or CF plot correctly in the instability domain, the remaining three dams plot incorrectly in the stability domain.
- One dam (Matakkitaki No. 2) was artificially lowered, however plots in the stability zone and has not been considered when assessing the applicability of the index.

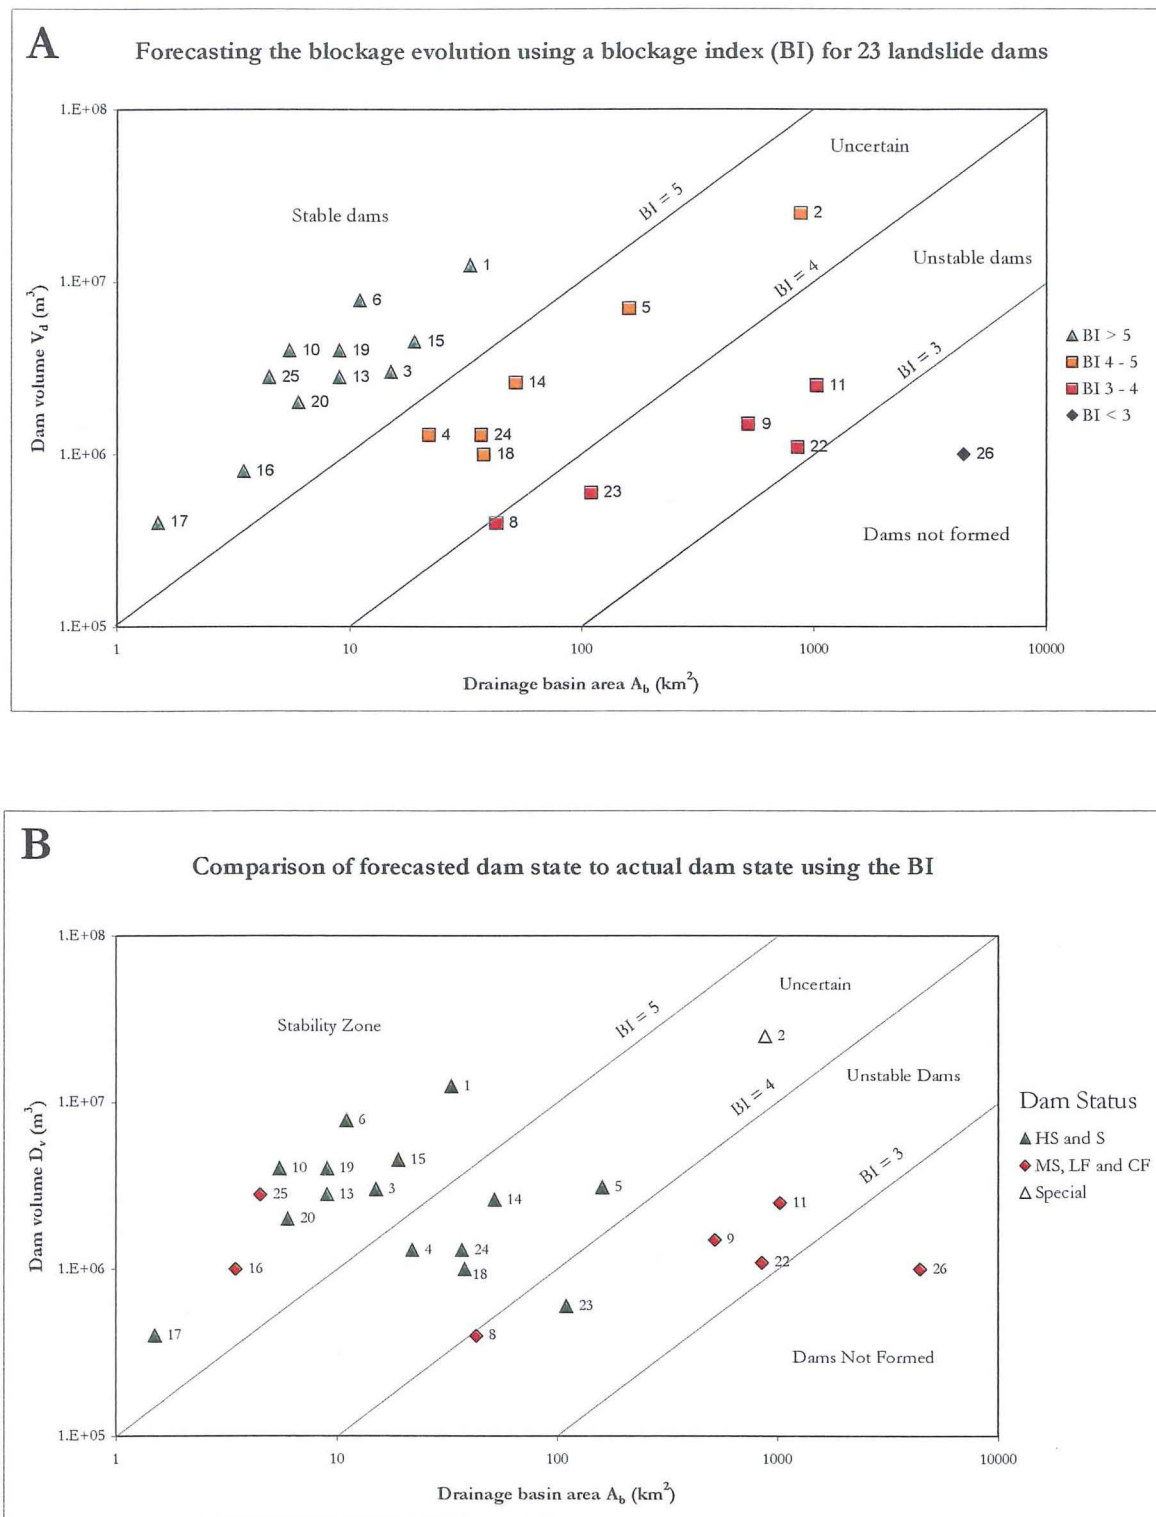
Fig 3.7 a shows that the dams are represented in all four possible domains. 11 of the 23 dams have a BI value > 5 which plot in the stability domain; six plot in the uncertain domain (BI between 4-5); five dams plots in the unstable domain (BI between 3-4) with the remaining one dam plotting in the dams not formed domain ($BI < 3$) (terminology follows Casagli and Ermini, 1999).

Fig. 3.7. A. Landslide dam volume versus drainage basin area for 23 landslide dams located throughout northwest Nelson defining stable and unstable domains. Numbers adjacent to points refer to database reference number. **B.** Comparison of actual state of landslide dam to that forecast using the BI. The terms stable and unstable are defined by Casagli and Ermini (1999); they have been used to describe the state of landslide dams in northwest Nelson (see text for definitions). Dams not formed and special cases are highlighted where appropriate.

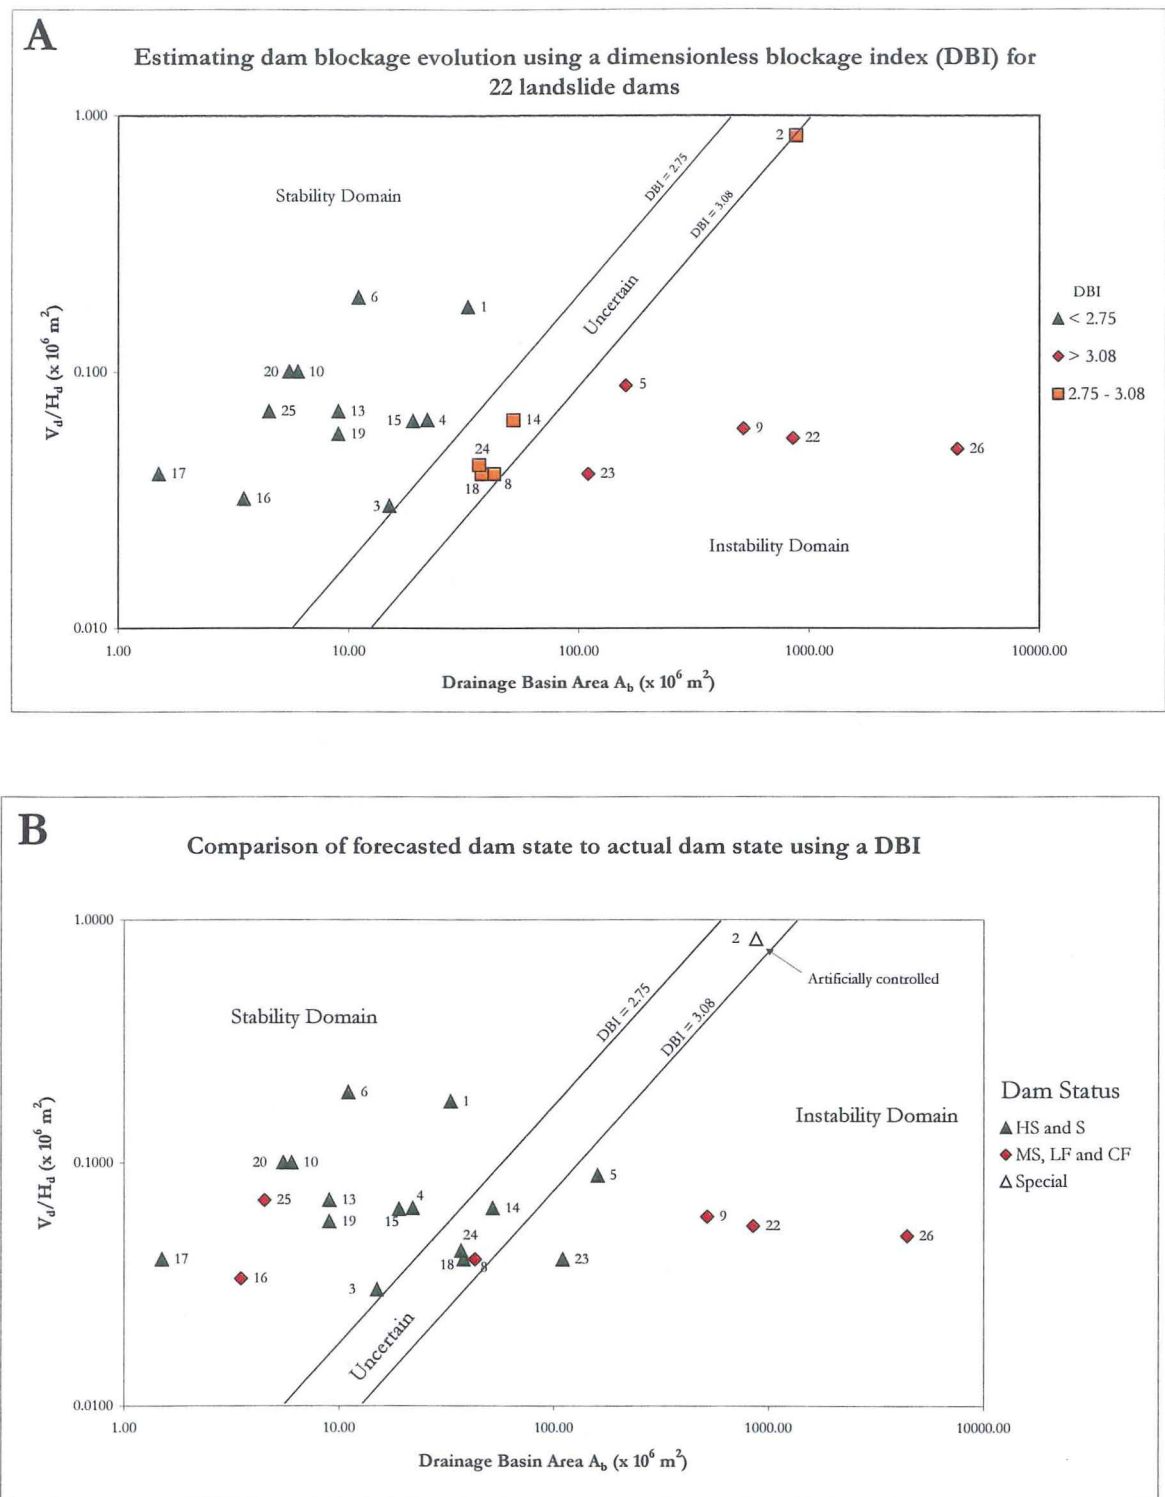
DBI calculations show 12 of the 22 Murchison and Inangahua dams plot in the stability domain ($DBI < 2.75$), five dams plot in the uncertain domain ($DBI 2.75 - 3.08$) and the remaining five dams plotting in the instability domain ($DBI > 3.08$).

Fig 3.8. A. Calculated dimensionless blockage index (DBI) for 22 landslide dams located throughout northwest Nelson indicating stable (<2.75) and unstable (>3.08) domains. Numbers adjacent to points refer to database reference number. **B.** Comparison of actual state of landslide dam to that forecast using the DBI. The terms stable and unstable are defined by Casagli and Ermini (1999); they have been used to describe the state of landslide dams in northwest Nelson (see text for definitions).

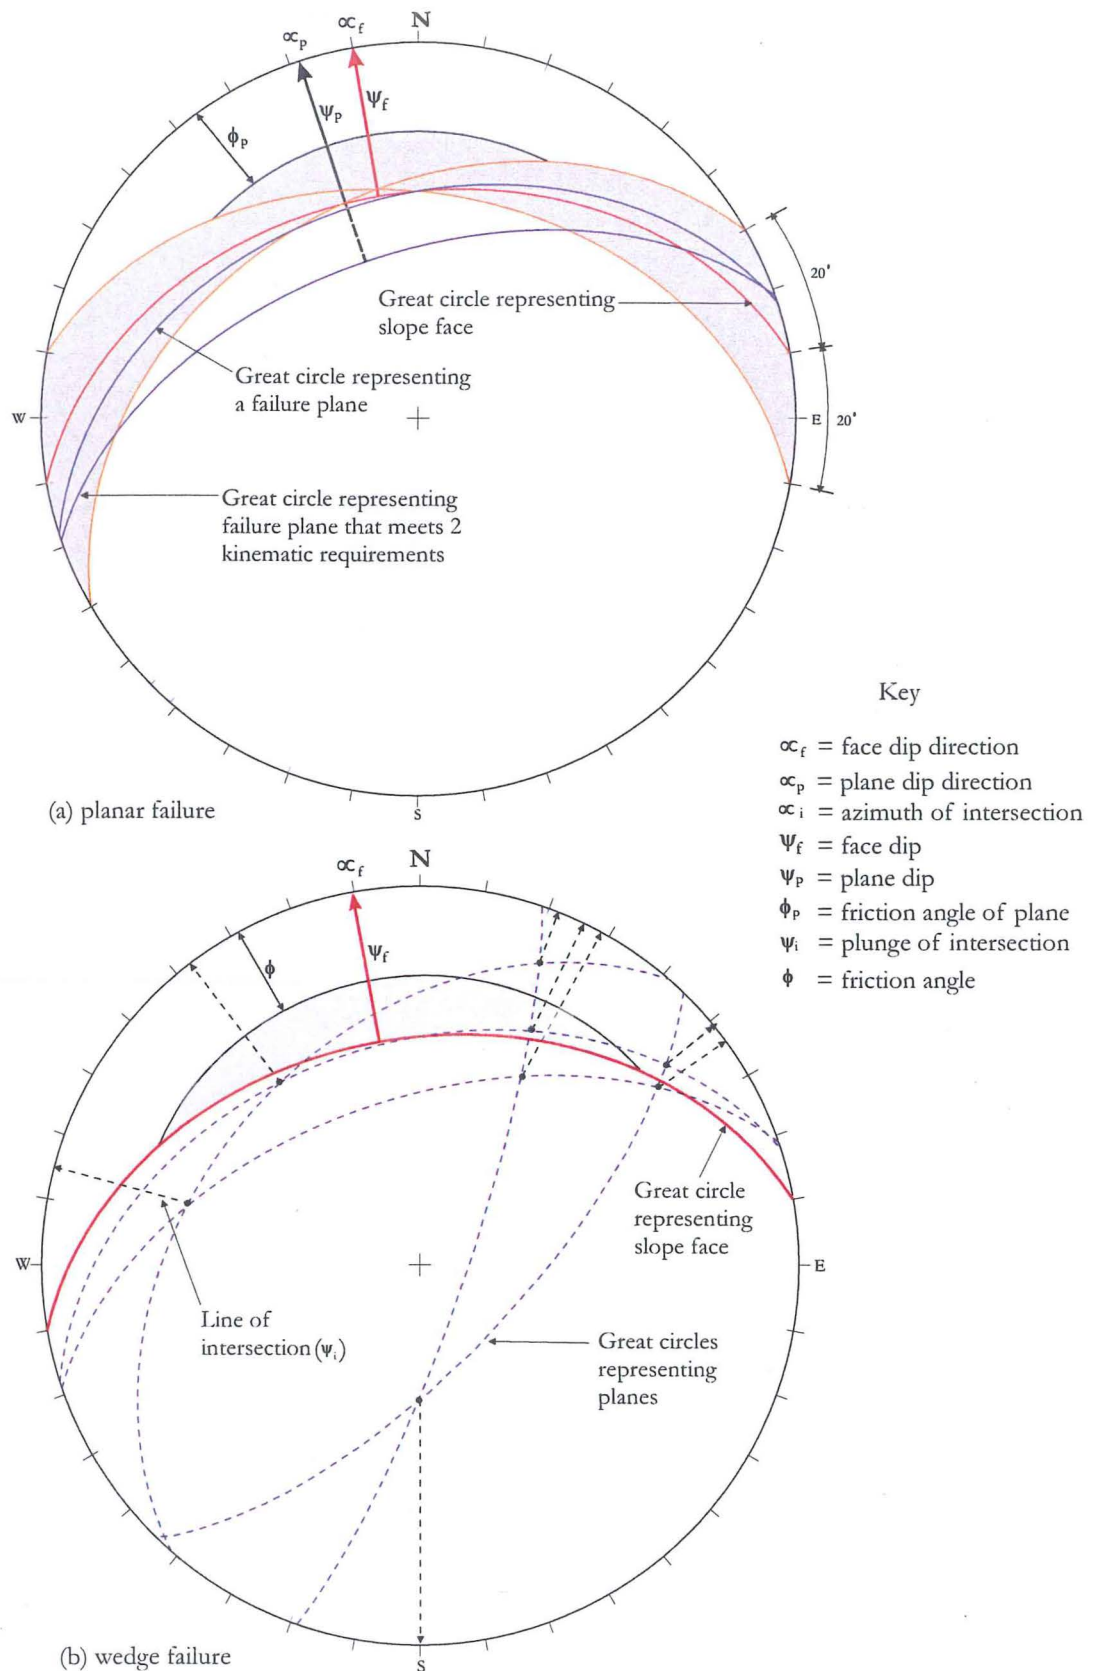
Fig 4.13 shows the equal area stereographic projection of five joints from the eastern lateral margin rock mass representing their dip and dip direction to assess its kinematic behaviour. The results show that planar failure is possible for one joint set, which satisfies all three structural conditions: 1) defect dip direction $\pm 20^\circ$ of the slope dip direction; 2) dip of the defect is less than the dip of the slope (defect daylights); and 3) dip of the defect is greater than the friction angle of the defect plane (conservatively estimated to be 28°). One other defect plane meets the requirements of 2 and 3, however does not daylight the slope, which dips at 55° . It is important to note that the slope does locally dip $> 55^\circ$, which may allow kinematically, failure to occur on this defect.

Wedge failure analysis from the eastern margin joint and bedding defects suggests that it is not kinematically possible for this type of failure to occur in the current state (Fig 4.13).

Fig 4.13. Stereographic projection for kinematic analysis of wedge and planar failure in Zone I rocks at Lake Stanley upper eastern lateral margin. Results show (a) planar failure is kinematically possible, and (b) wedge failure is not kinematically possible based on the limited number of defects used for the analysis.

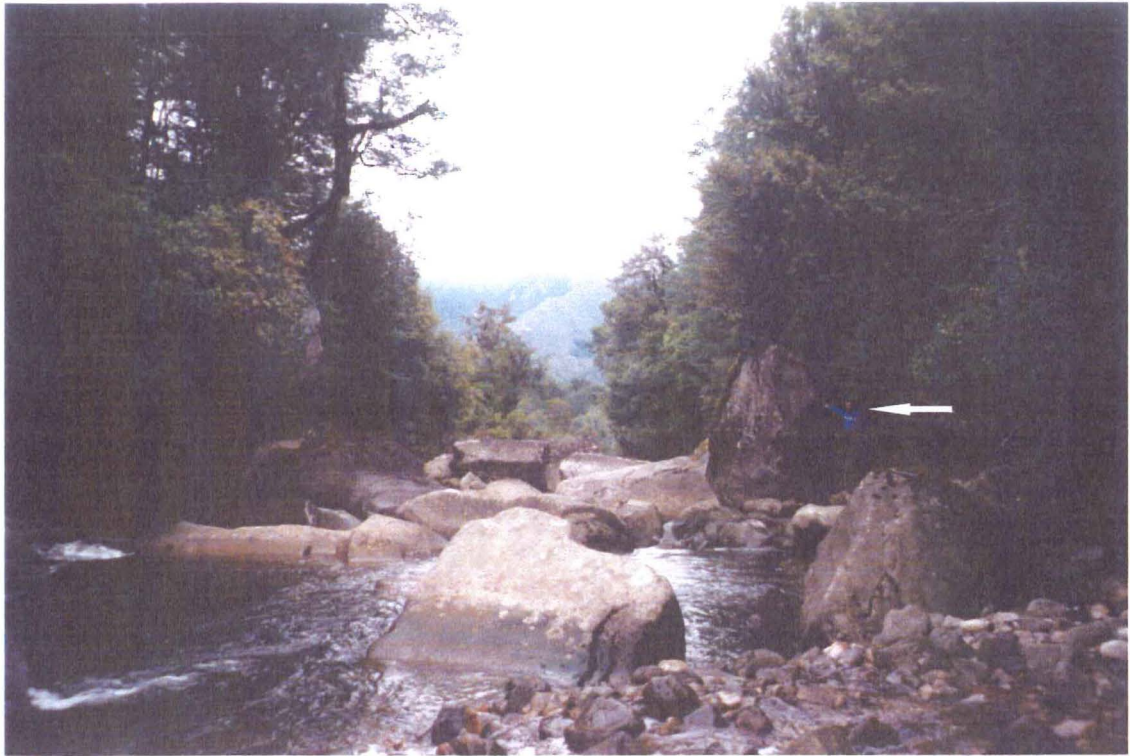
Overtopping of the dam crest via three natural spillways is the main mechanism draining the lake (Map 4 and 5.17), however, seepage through the dam material may account for as much as 5% (?) of impoundment drainage.

Fig. 5.17. Photo at the dam crest looking south at the main spillway. This photo was taken in April 2002 showing a moderate flow over the crest into the main spillway. Note the large boulders are up to 4m in diameter. (Person for scale indicated by the arrow in the middle right of the photo). The fine debris in the foreground is from a tributary that flows over the dam material from the west at right angles to the flow of the Matiri River (Location 4, Map 4).

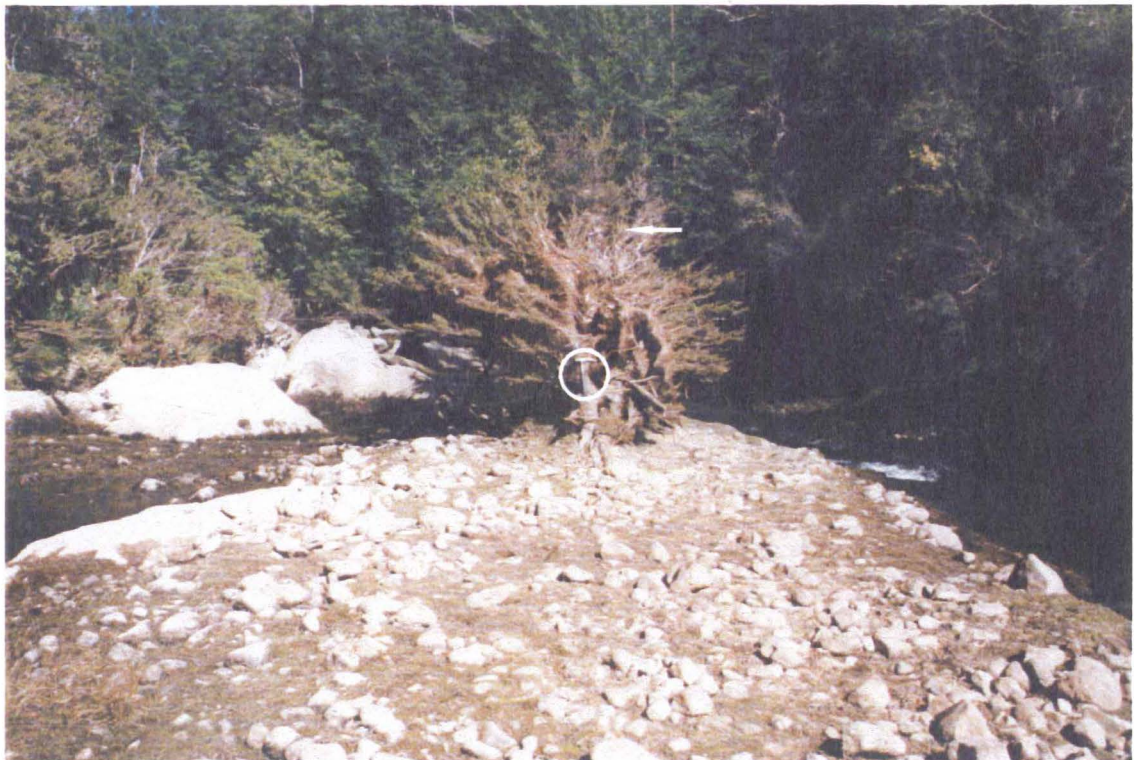
Fig 5.18. View of the main spillway looking southwest at a position distal to the landslide source. Flow rate at time of photograph (February, 2003) is 0.3m lower than flows observed in April 2002. High flows are evident based on the debris deposited up to 2m above the average lake level (arrow). Note the large sandstone boulders in the left of the image. The smaller blocks in the foreground are from a small tributary entering from the right of the image (Location 4, Map 4).

Lake volume and hence flow over the dam crest is seasonally variable with higher flows recorded in winter where the inflow into the lake is a lot higher than in the dryer summer months, which corresponds to lower flows over the dam crest. The seasonal variation was demonstrated during field reconnaissance in April 2002 and February 2003 with the lake level about 300mm lower in February than in April the previous year (Fig 5.18). The lower lake level in February corresponded to a lower flow of water over the dam crest and in the spillway on the downstream dam face. Fig 5.18 illustrates flood debris 2m above the average lake level demonstrating the ability of the dam to resist high flood flows over the crest and on the downstream dam face. A flow gage at the lake outlet between 1979 and 1993 (site 93214; NZMG 2454500:5949200; *pers comm.*, K. Walter, NIWA, 2003) measured a maximum flow of $37 \text{ m}^3/\text{s}$ in September 1980 which again demonstrates the high flows that must occur during flood events.

Based on the dam material's high resistance to erosion from overtopping and seepage, even during high flows (refer Fig 5.18), the future performance of the dam in resisting erosion both internally and externally, is not likely to change in the foreseeable future and suggests relative long-term stability even under future severe events (N.B. 1929 earthquake did not

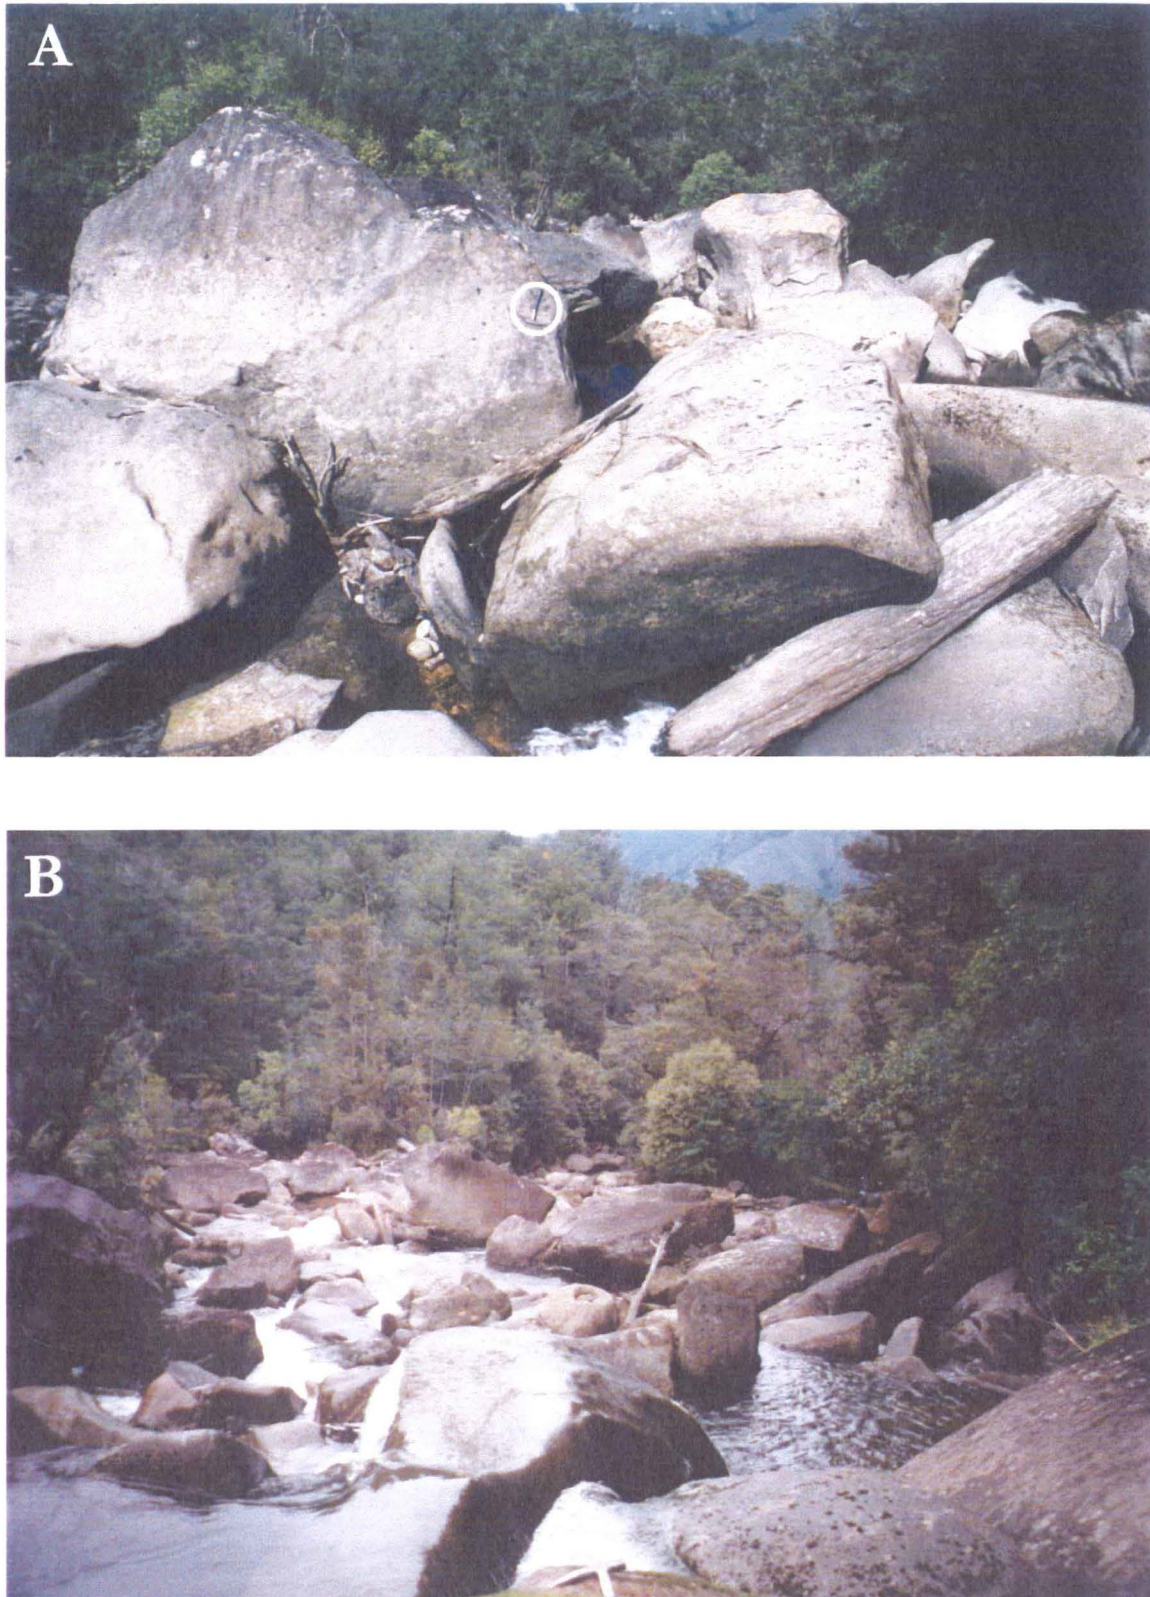
All three spillways on the downstream dam face display heavy armouring by large ($> 4 \text{ m}$) rounded blocks as described above, with several additional ephemeral spillways also displaying heavy armouring (Fig 5.19). Flow was present in the primary channel during field reconnaissance in April 2002 and February 2003, but several of the secondary flood channels were not occupied during this field reconnaissance. (Map 4 and Fig 5.17, 5.19).

Fig 5.19. A. Photograph of blocks lining the spillway on the downstream face of the dam, location 3 Map 4. The maximum size of the blocks in the photo is 4m in diameter. Rock hammer circled for scale. B. View of the spillway on the downstream face of the dam looking southeast location 3, Map 4. Note the surface flow has increased slightly from the previous photo indicating less subsurface flow is occurring. Block sizes are still large with a maximum in this photo of 4m in diameter. Note also, the well established vegetation on the dam material to the sides of the spillway.
